**Graymont Western U.S., Inc.**  
**Cricket Mountain Project, Utah**

**Notice of Intention to Revise Mining Operations**  
**Big Sage**

*Revised September 2008*  
*Revised December 2007*  
*Revised May 2007*  
**SRK Project No. 138406**

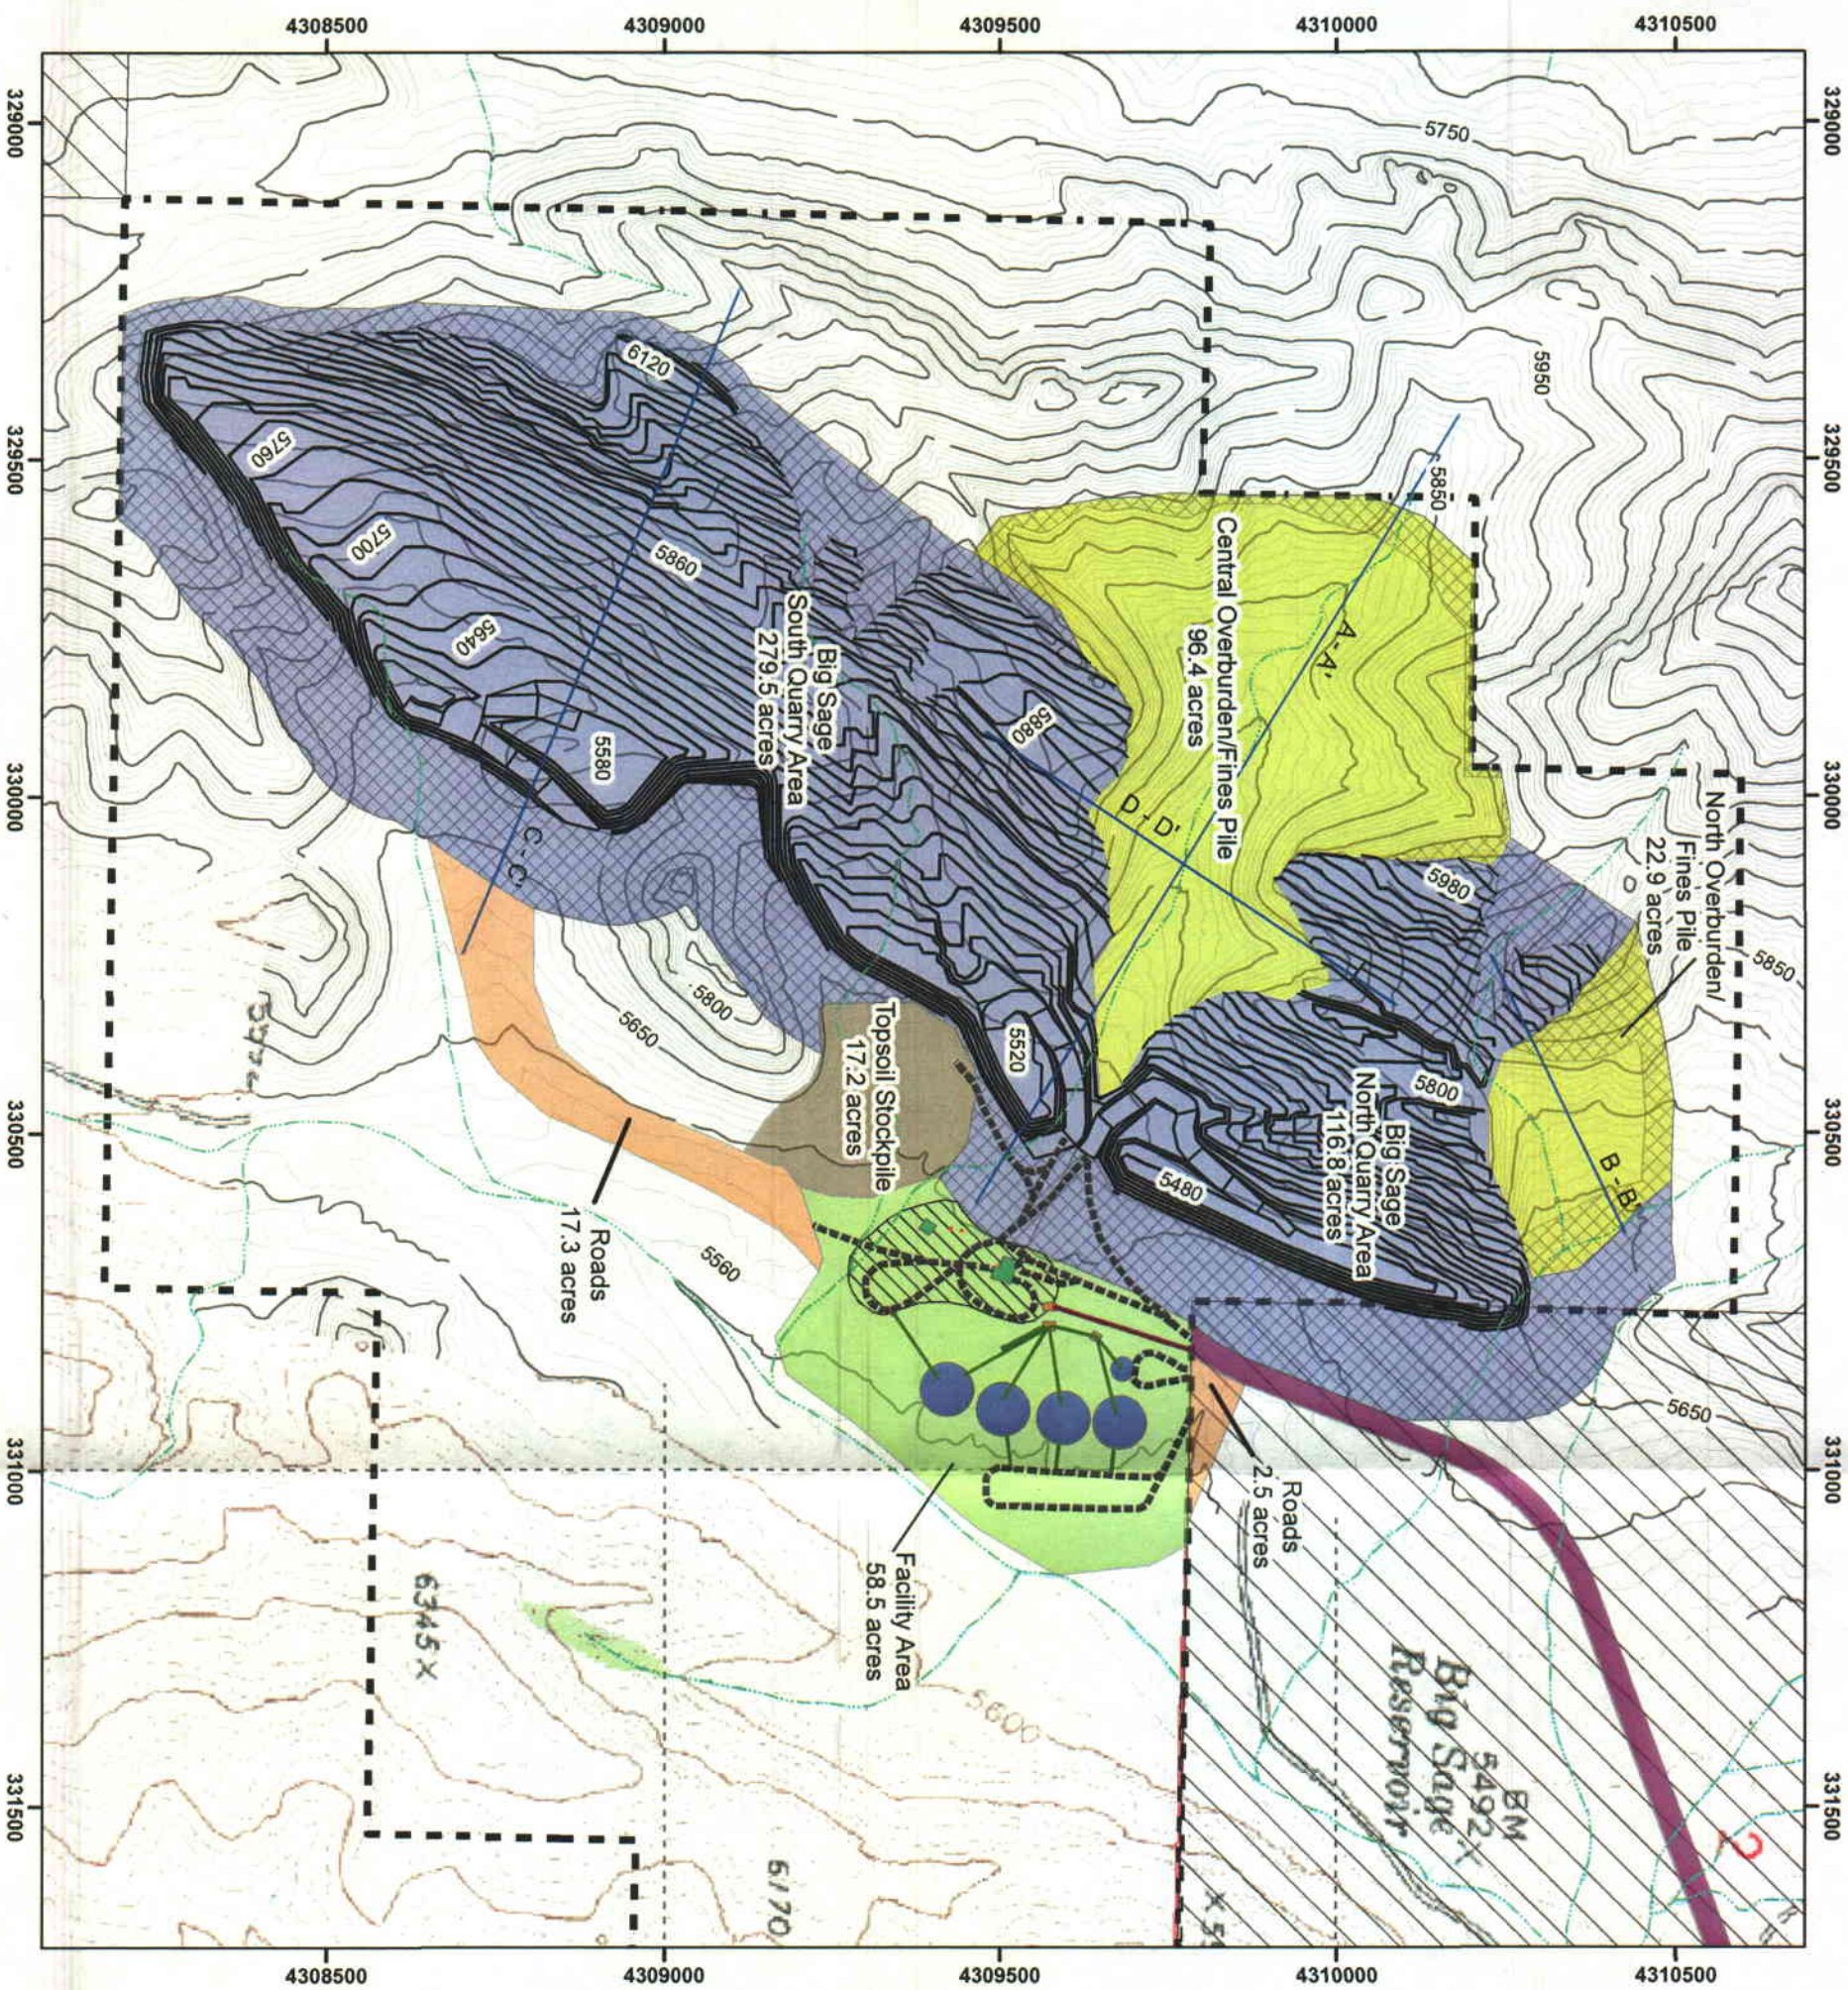
Figure 3. Big Sage Quarry Layout

The bonded area is equal to the permitted area. Consideration has been given in design to prevent disturbance of adjacent lands. Mitigations include slope design and voluntary setbacks. Although the bonded area boundary and the property boundary is equivalent in some areas, disturbance has not been planned within 50 feet of the property boundary. This can be observed in Figures 3, 7, and 9.

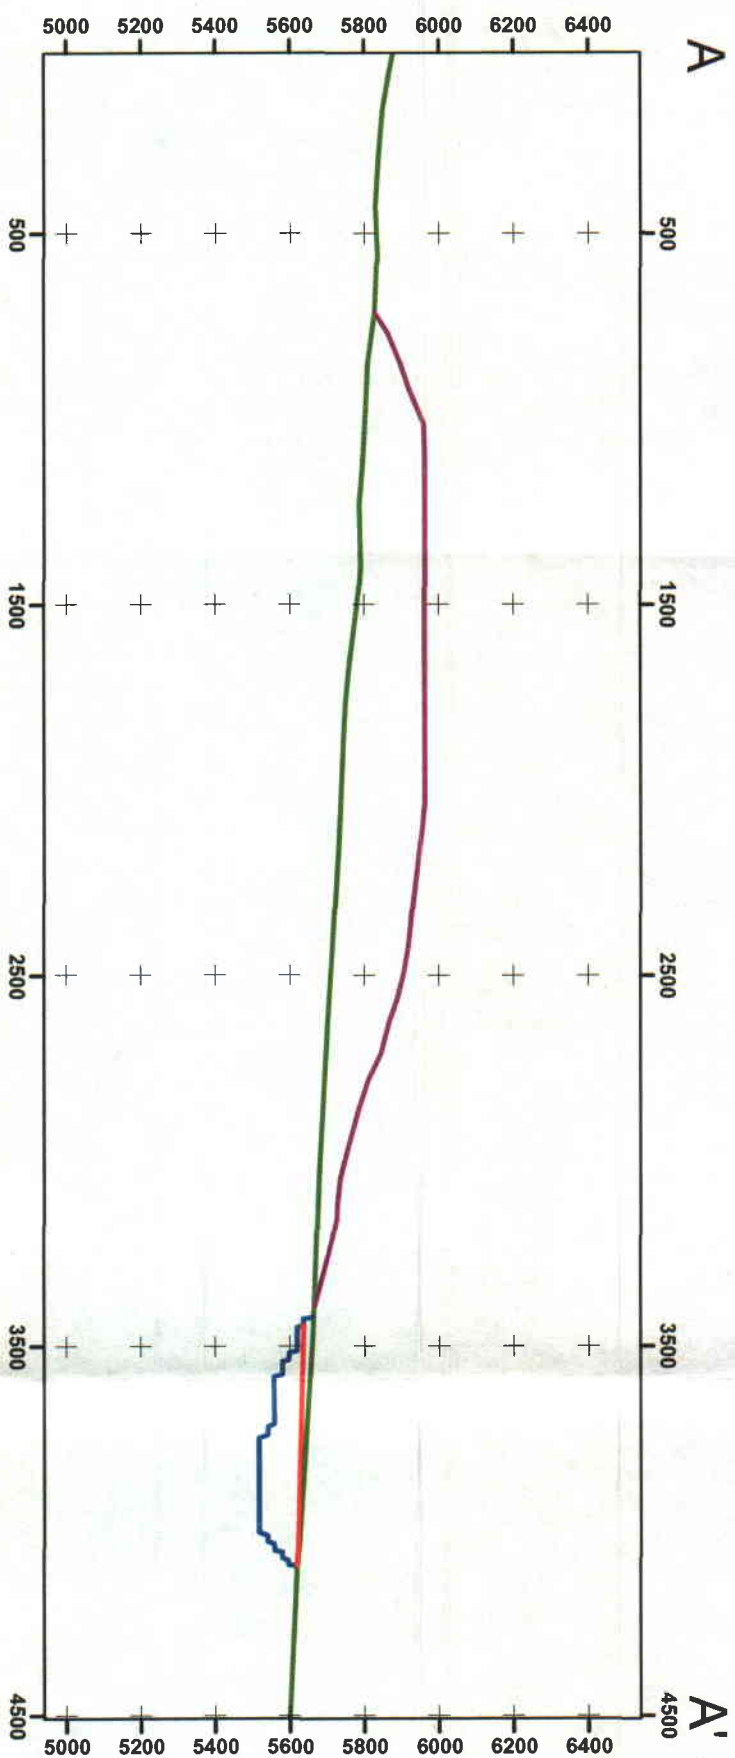
shown in Figure 5 as well as shallow slopes (35 degrees or less for the overburden/fines piles and less than 45 degrees for the quarry slopes), the areas between the overburden/fines piles and the quarry will be stable.

**Figure 5. Conceptual Cross-Sections**  
Rev. May 13, 2008  
Graymont Western US Inc.

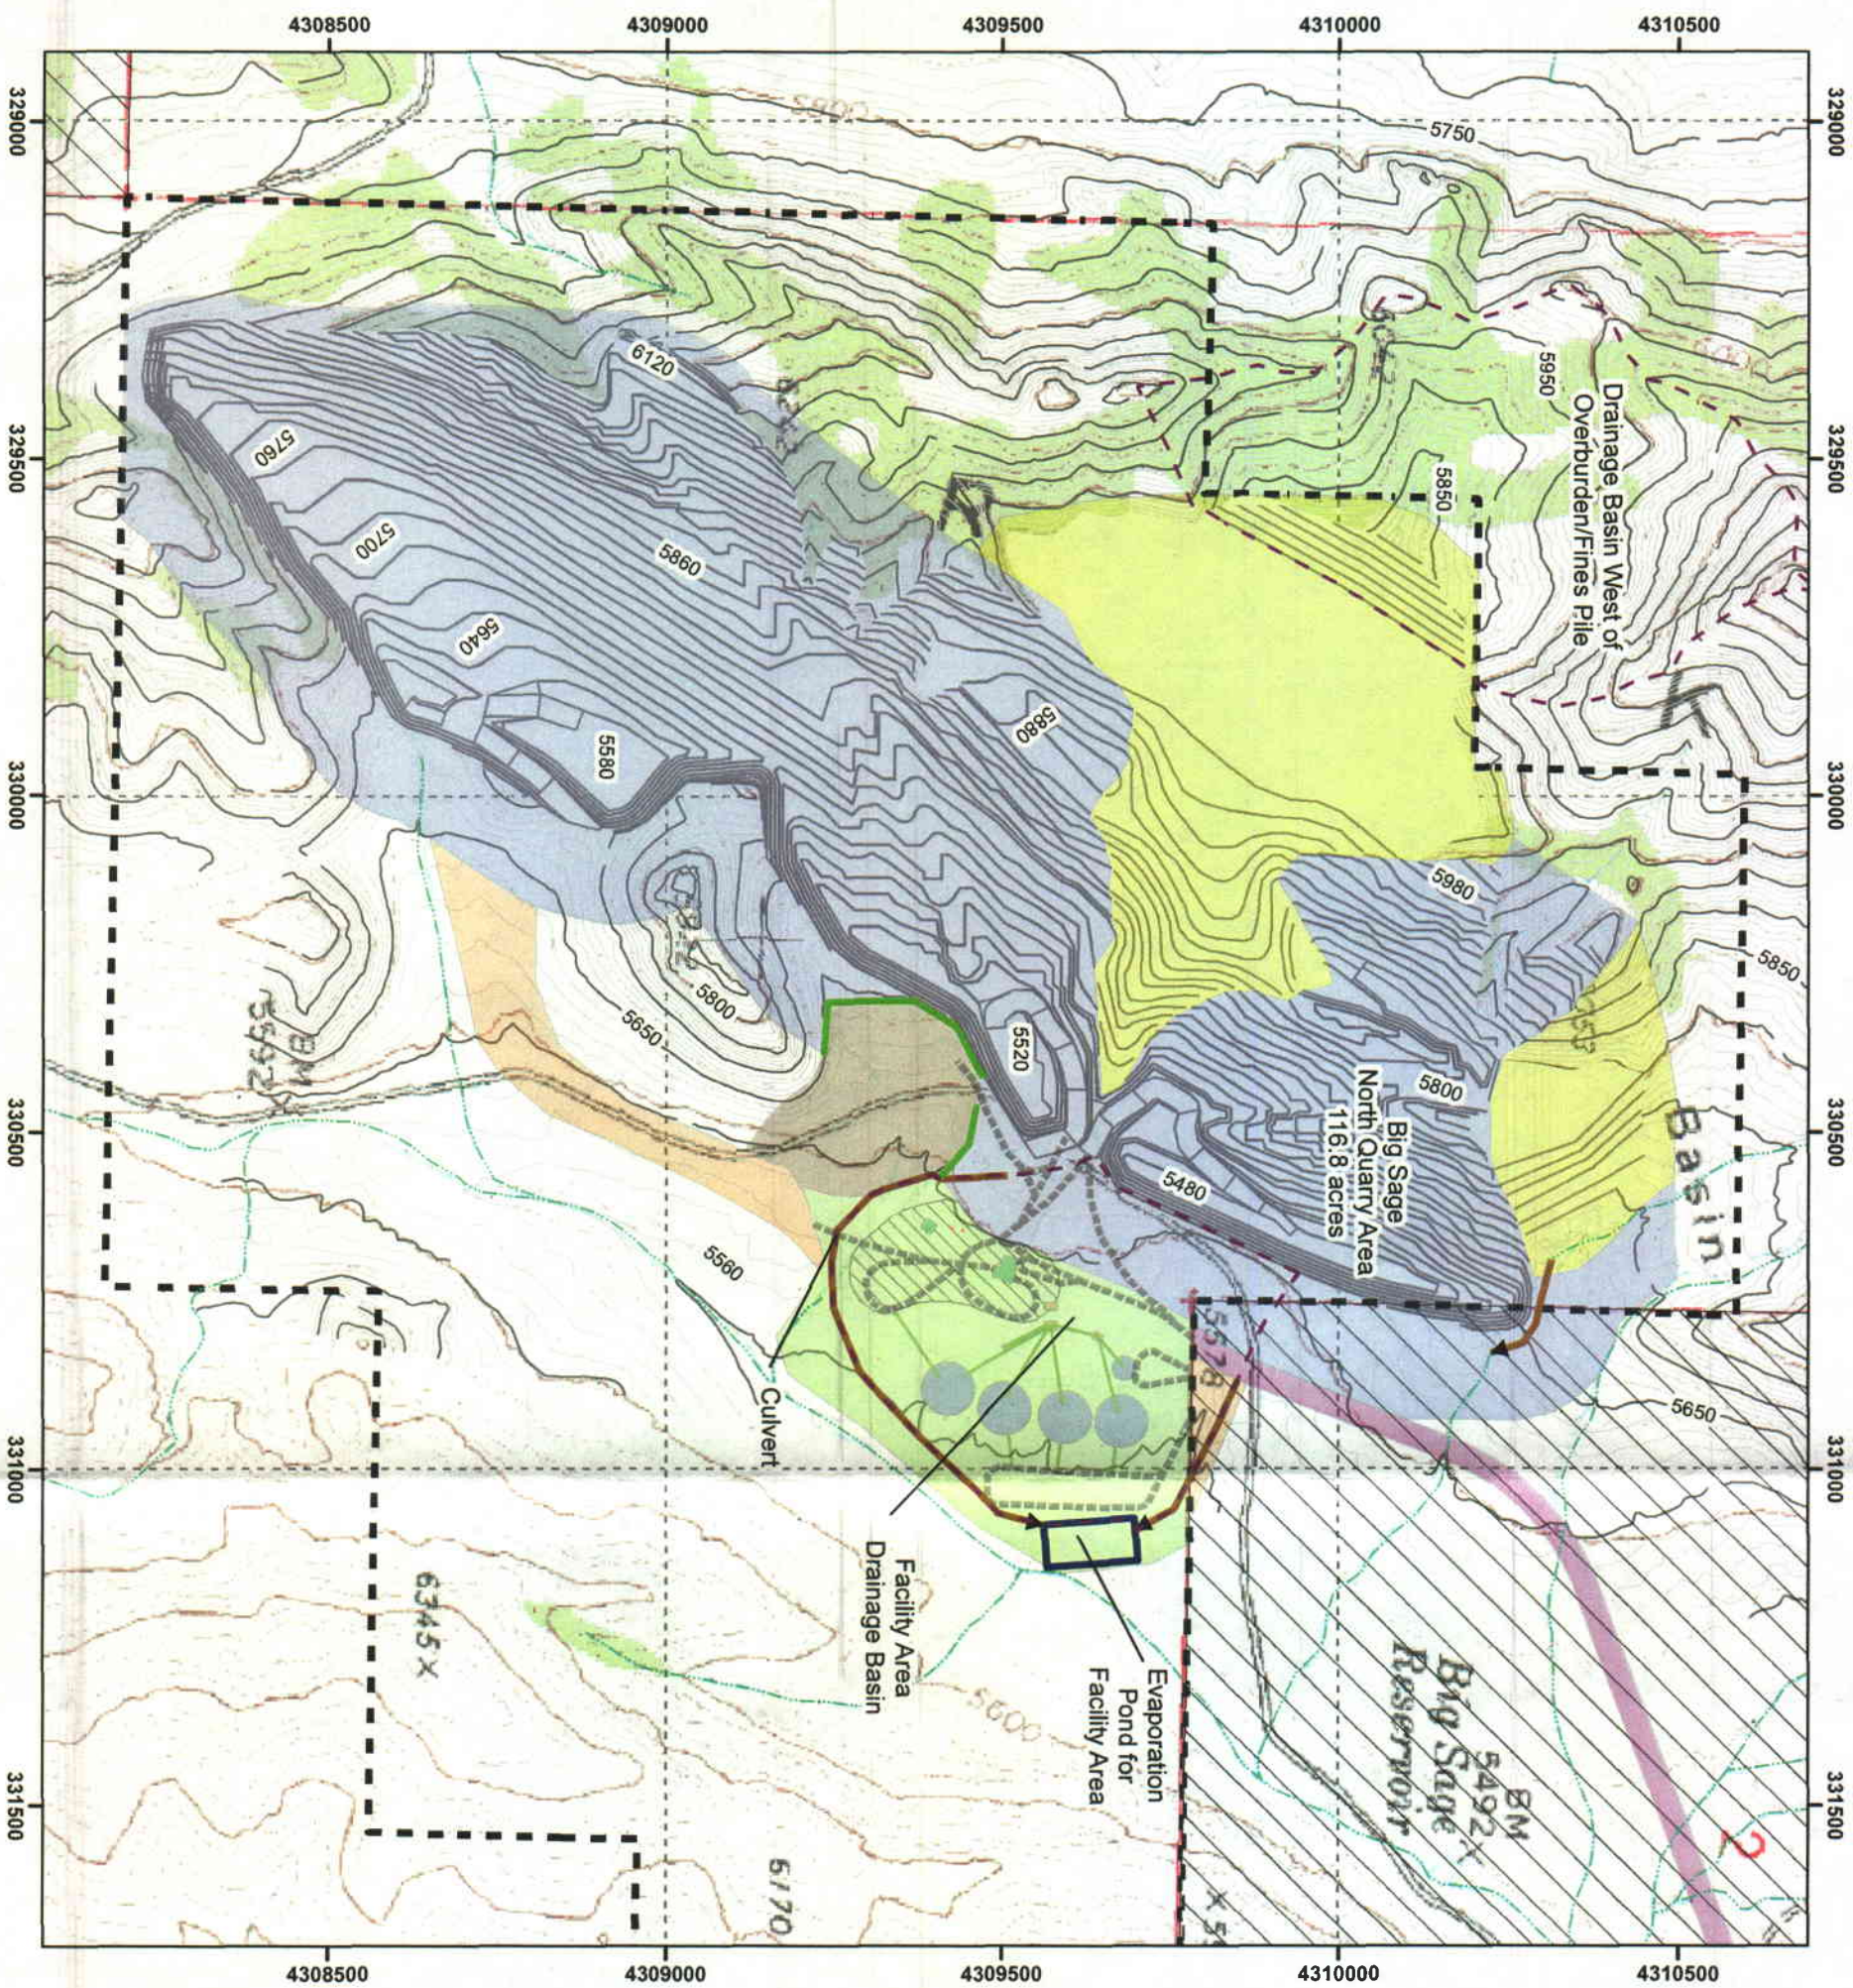
**Figure 7. Conceptual Stormwater Management Map**

**The watershed map, Figure 7, is of too large a scale to show watershed boundaries. In order that the Division accept this plan it is required that the boundaries of the contributing watersheds be shown and the resulting drainage and impacts be clearly shown. Figure 7 fails to clearly show all these boundaries as the figures does not show a large enough area or provide all the drainage boundaries and contributing watershed areas. Diversion ditches, berms, swales, and ponds are identified without any engineering detail in the plan. Please provide this detail. (TM)**

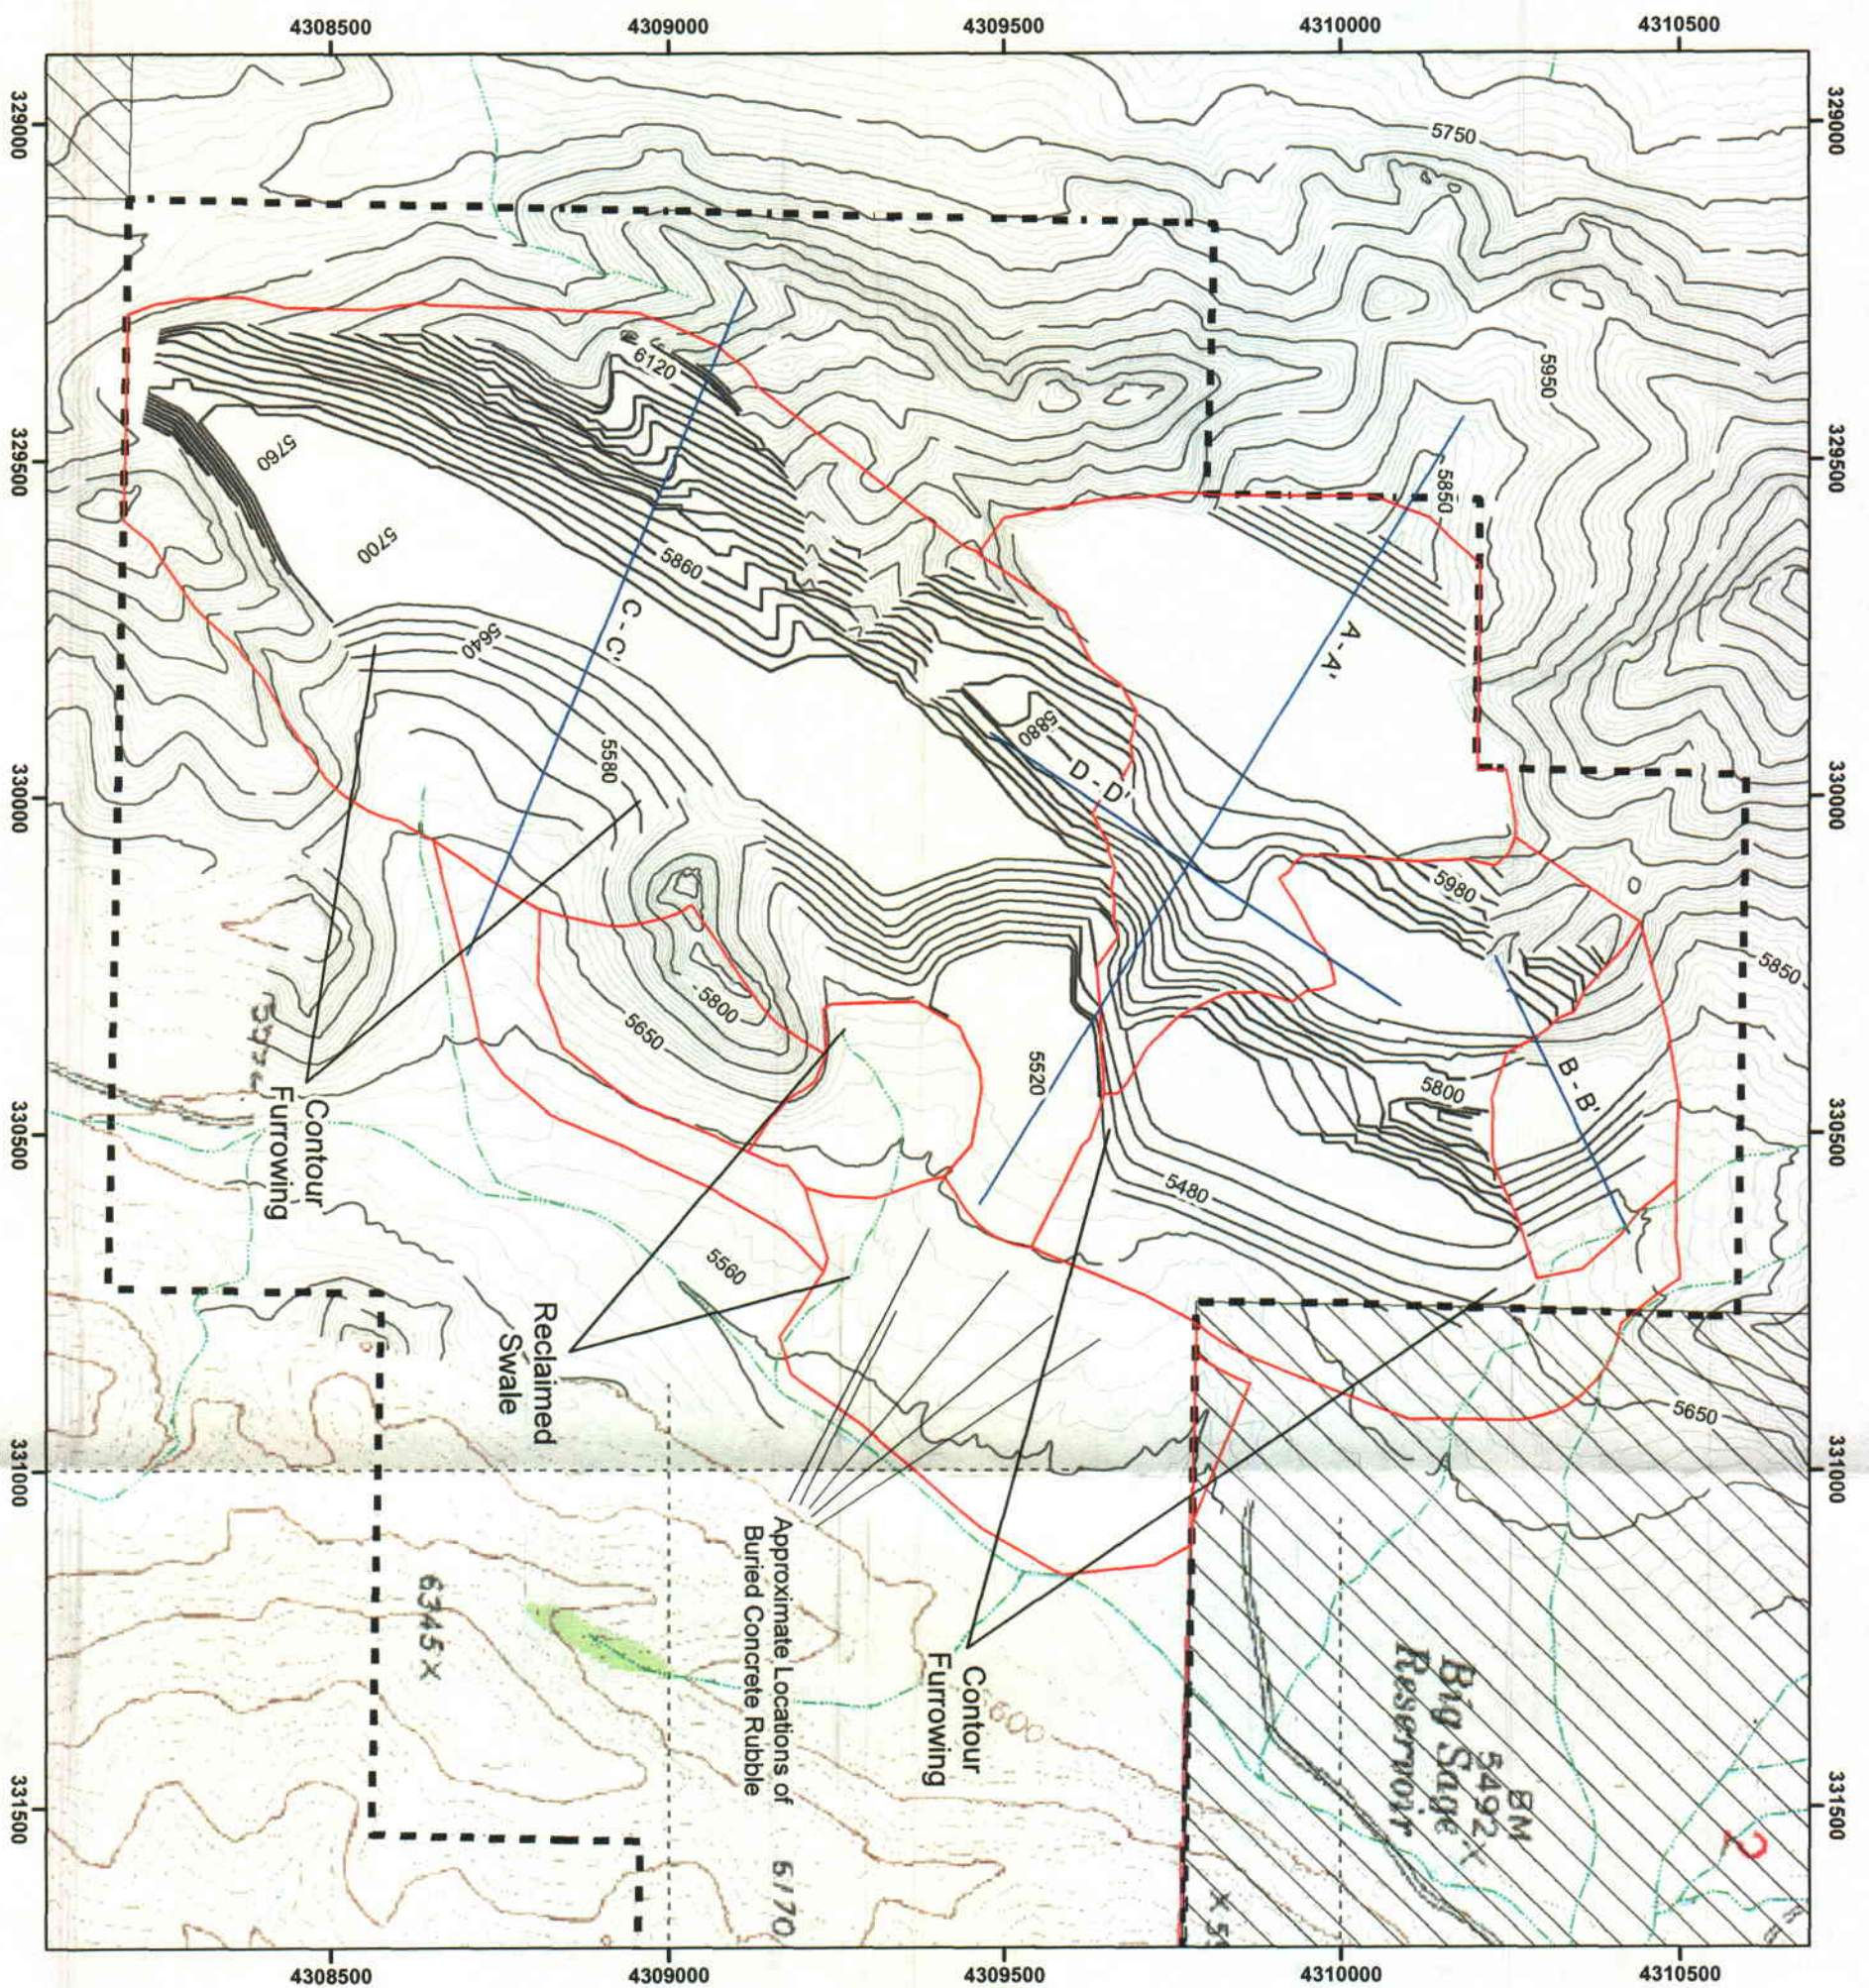
**Figure 9. Conceptual Reclamation Map**

the surety narrative has been changed to reference Figure 6 for the location of these features. Deleterious materials storage sites are not present as noted in sections 2.4.18 Erosion and Sediment Control, 3.1 Surface and Ground Water Resources, and 4.6.3 Overburden/Fines Piles. The general locations of concrete rubble are noted in Figure 9.
